Monthly Oversight Report 67
44728 AES [46526 RAC]
ACS NPL Site
Griffith, Indiana
July 1, 2006 - August 4, 2006

Subject: Monthly Oversight Summary Report
No. 67 for July 2006

Monthly Oversight Summary Report No. 67
ACS Superfund Site
TO 057, 44728.238 (AES) [WA57, 46526.238 (RAC)]

Reporting Period: Month of July (July 1 through August 4, 2006)

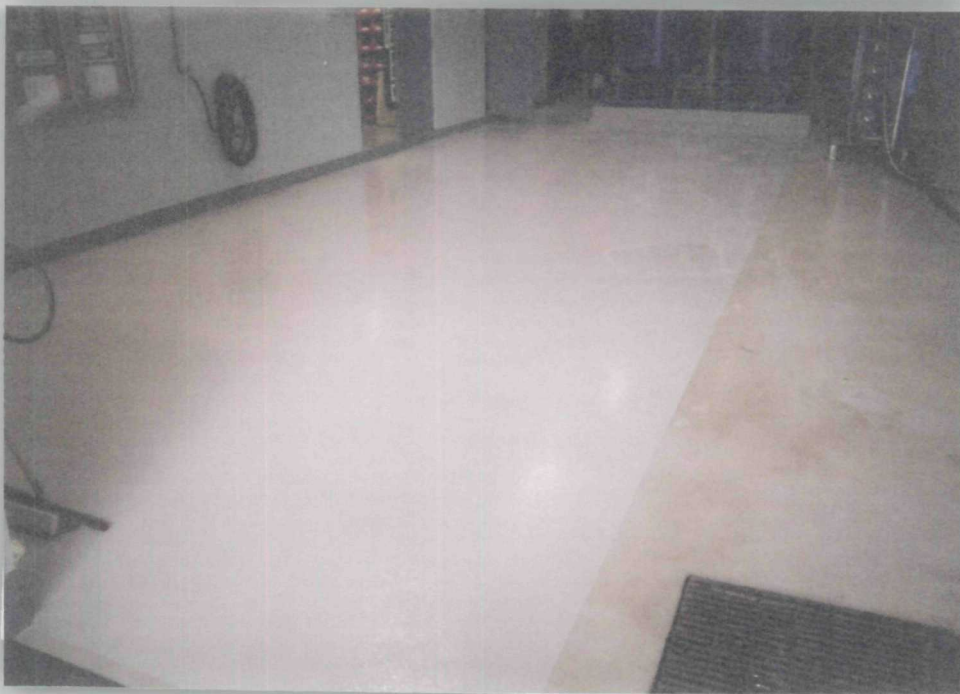
Site: American Chemical Service, Inc.
Proj. #: 44728 AES [46526 RAC]
Roll: 88 Photo #9
Date: 7-13-06 Time: 1442
Photographer: Larry Campbell
Description: Photo facing southwest showing newly recoated floor in GWTP.

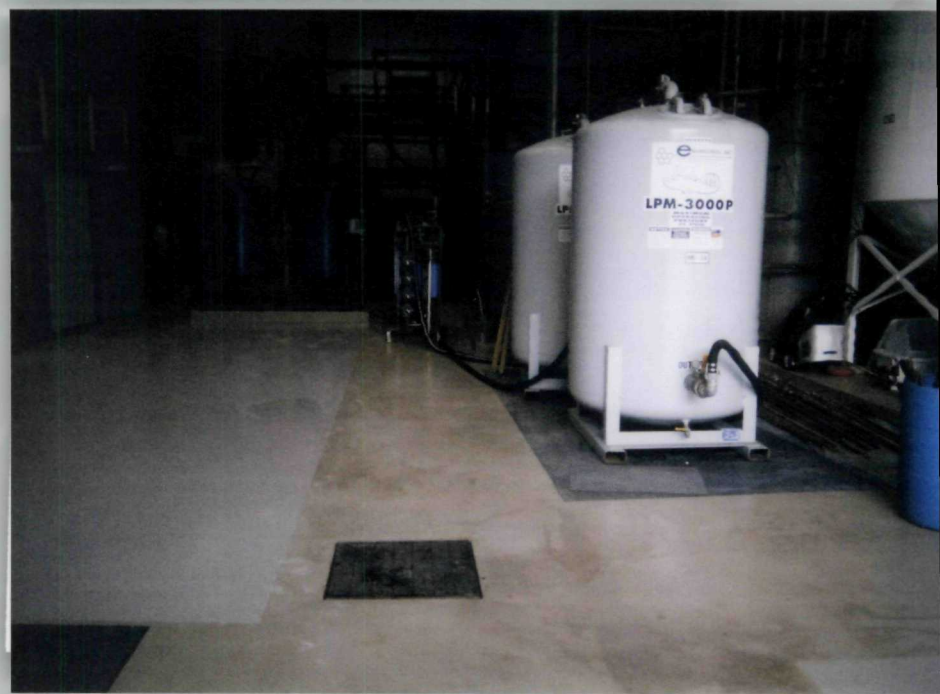
Site: American Chemical Service, Inc.
Proj. #: 44728 AES [46526 RAC]
Roll: 88 Photo #10
Date: 7-13-06 Time: 1443
Photographer: Larry Campbell
Description: Photo facing south showing relocated GAC tanks so floor could be recoated.

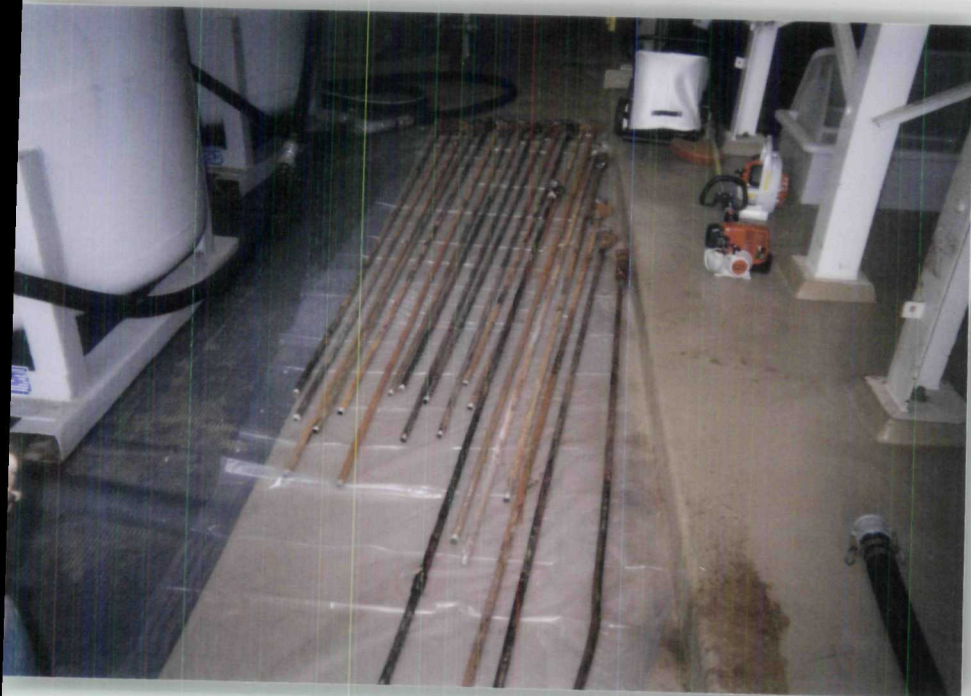
Site: American Chemical Service, Inc.
 Proj. #: 44728 AES [46526 RAC]
 Roll: 88 Photo #11
 Date: 7-13-06 Time: 1444
 Photographer: Larry Campbell
 Description: Photo facing south showing riser pipes
 from SBPA ISVE DPE pumps.

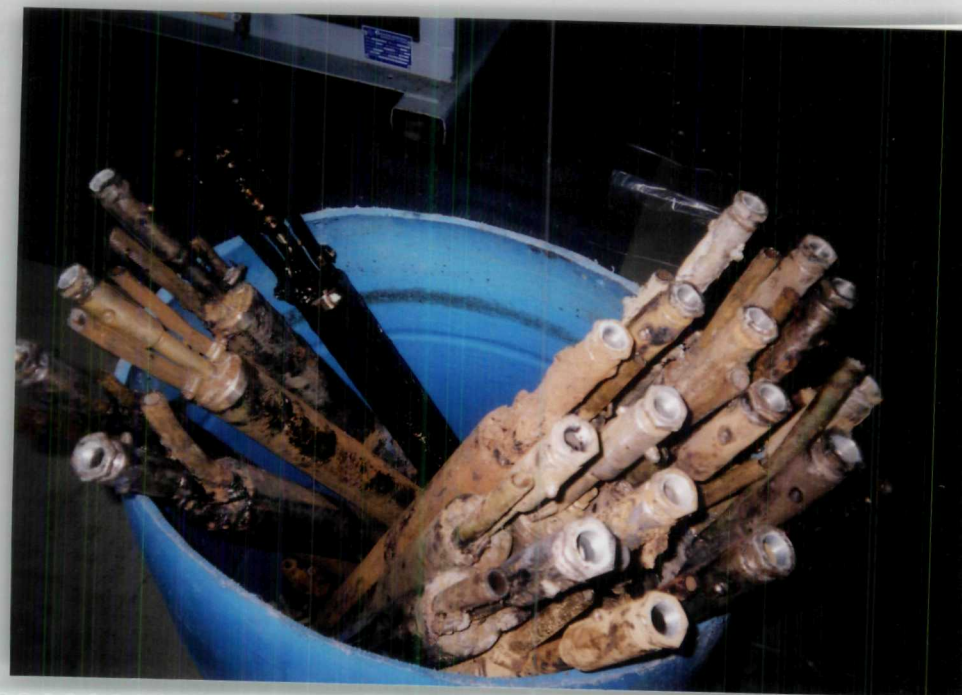
- MWH reported that Independent Environmental Services (IES) removed the dual-phase extraction (DPE) pumps from all DPE wells in the Still Bottoms Pond Area (SBPA) on July 10. MWH performed the annual servicing and cleaning of the DPE pumps in the GWTP. MWH reported that four of the DPE pumps required replacement.

Site: American Chemical Service, Inc.
 Proj. #: 44728 AES [46526 RAC]
 Roll: 88 Photo #12
 Date: 7-13-06 Time: 1445
 Photographer: Larry Campbell
 Description: Photo facing southeast showing dual
 phase extraction (DPE) pumps removed from SBPA
 wells for cleaning.

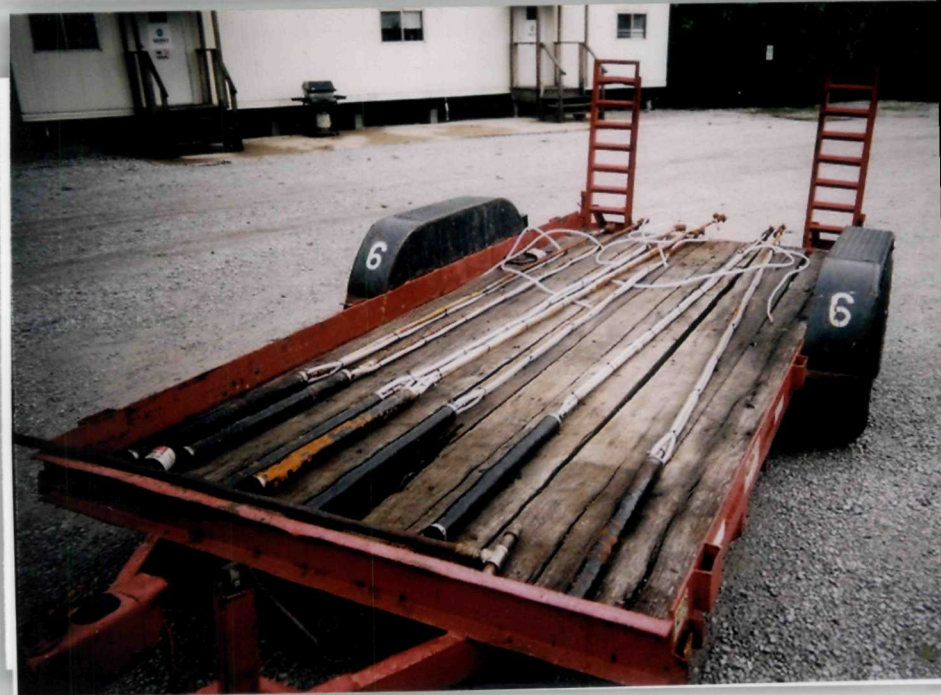
Site: American Chemical Service, Inc.
Proj. #: 44728 AES [46526 RAC]
Roll: 88 Photo #18
Date: 8-03-06 Time: 1010
Photographer: Larry Campbell
Description: Photo facing north showing cleaned dual phase extraction (DPE) pumps and risers on trailer to be moved to SBPA for installation by Independent Environmental Services (IES) personnel.

- MWH reported that IES reinstalled the cleaned and serviced DPE pumps in their wells in the SBPA on August 2 and 3. MWH reported that DPE pumps could not be installed in wells SVE-61 and SVE-79 because of sludge in the wells. MWH plans to clean the sludge from the wells by jetting. BVSPC observed the DPE pump installations on August 3.

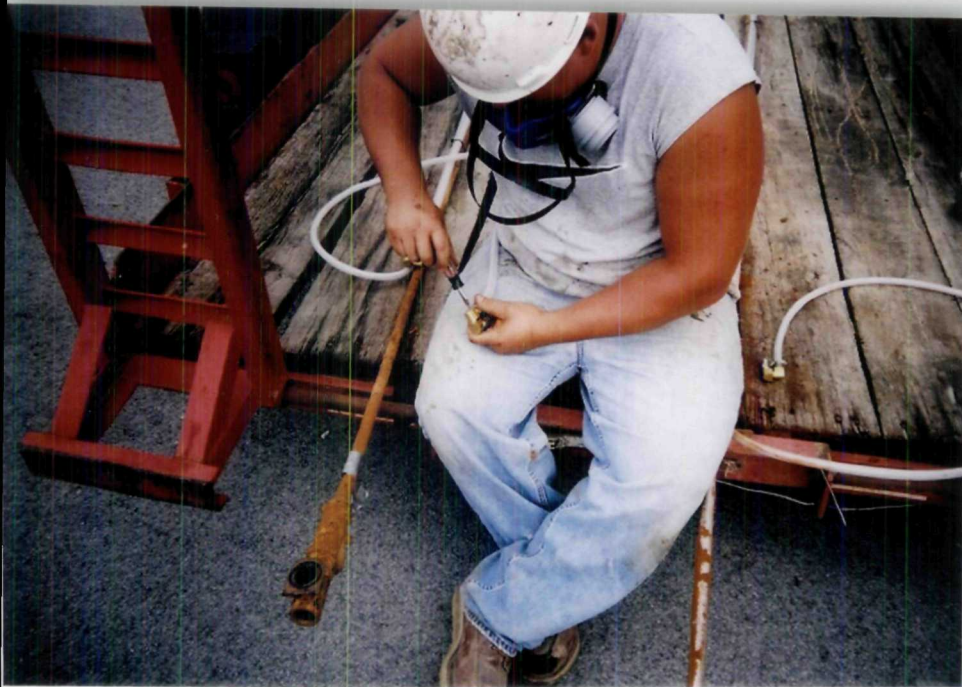
Site: American Chemical Service, Inc.
 Proj. #: 44728 AES [46526 RAC]
 Roll: 88 Photo #19
 Date: 8-03-06 Time: 1050
 Photographer: Larry Campbell
 Description: Photo facing down looking at IES technician installing clamp on air line to DPE pump.

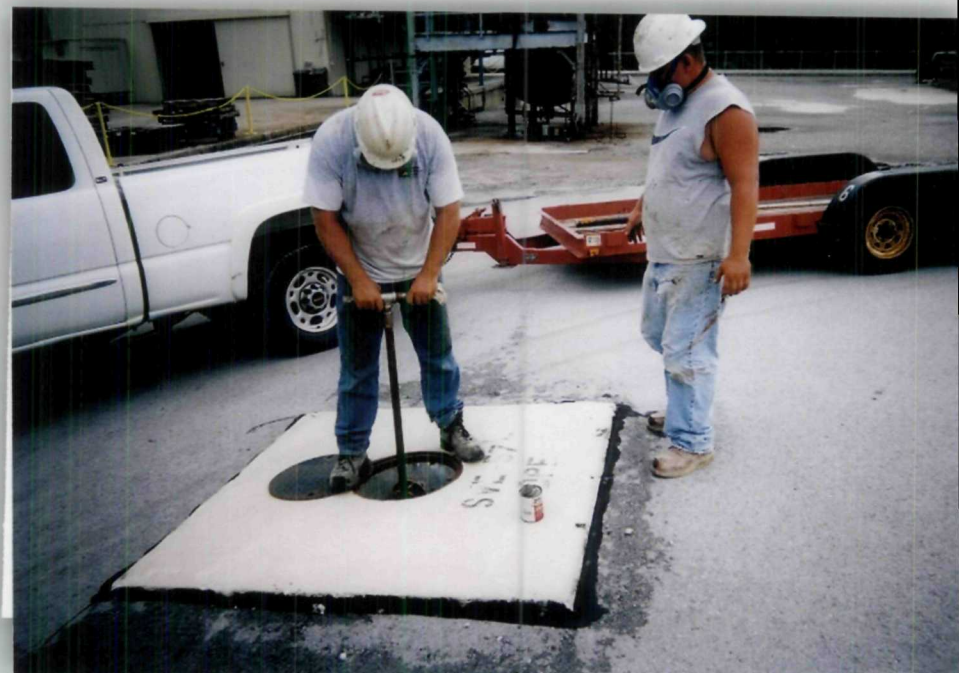
Site: American Chemical Service, Inc.
 Proj. #: 44728 AES [46526 RAC]
 Roll: 88 Photo #20
 Date: 8-03-06 Time: 1052
 Photographer: Larry Campbell
 Description: Photo facing east showing IES technicians installing DPE pump in well SVE57. Note use of respirators when working in close proximity to open well.

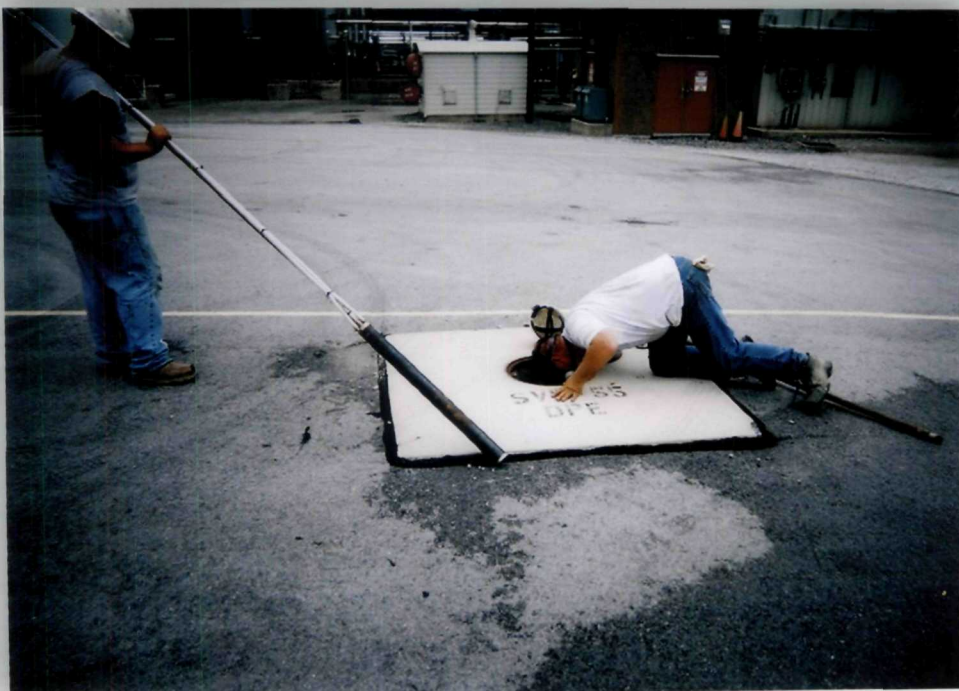
Site: American Chemical Service, Inc.
Proj. #: 44728 AES [46526 RAC]
Roll: 88 Photo #21
Date: 8-03-06 Time: 1055
Photographer: Larry Campbell
Description: Photo facing north showing IES technician preparing to install DPE pump in well SVE55.

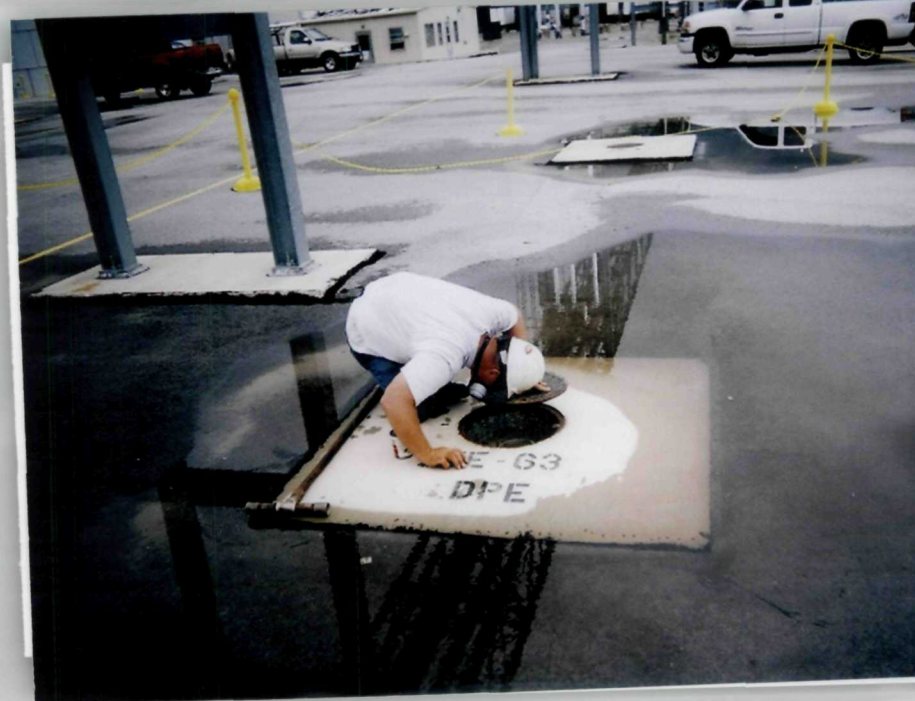
Site: American Chemical Service, Inc.
Proj. #: 44728 AES [46526 RAC]
Roll: 88 Photo #22
Date: 8-03-06 Time: 1058
Photographer: Larry Campbell
Description: Photo facing north showing IES technician at well is checking the orientation of the pitless adaptor for proper alignment of the riser pipe in well SVE63..

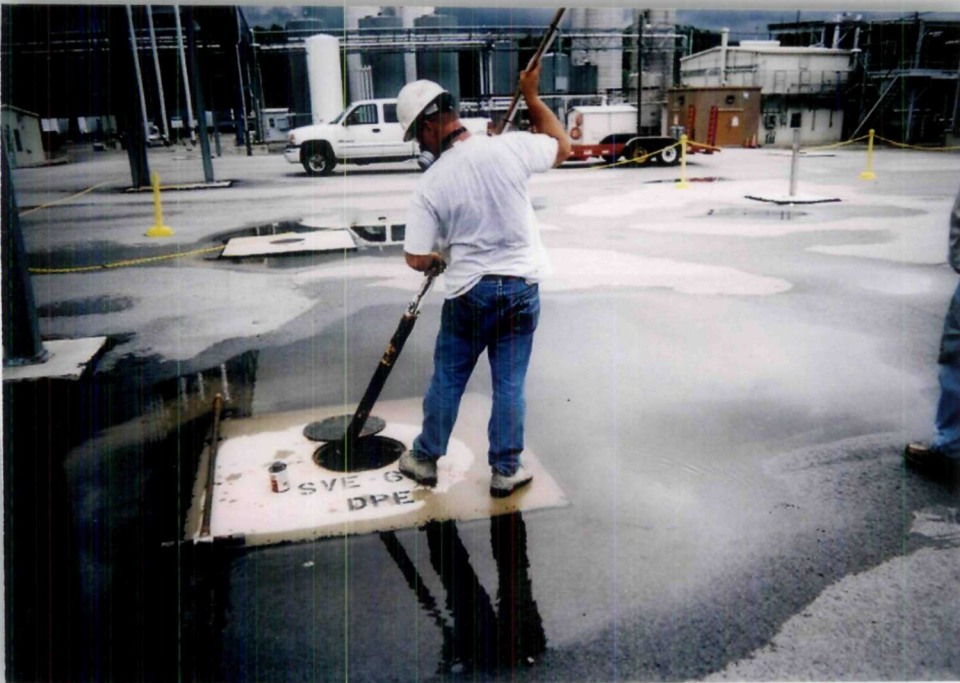
Site: American Chemical Service, Inc.
 Proj. #: 44728 AES [46526 RAC]
 Roll: 88 Photo #23
 Date: 8-03-06 Time: 1059
 Photographer: Larry Campbell
 Description: Photo facing north showing IES technician preparing to lower DPE pump into well SVE63.

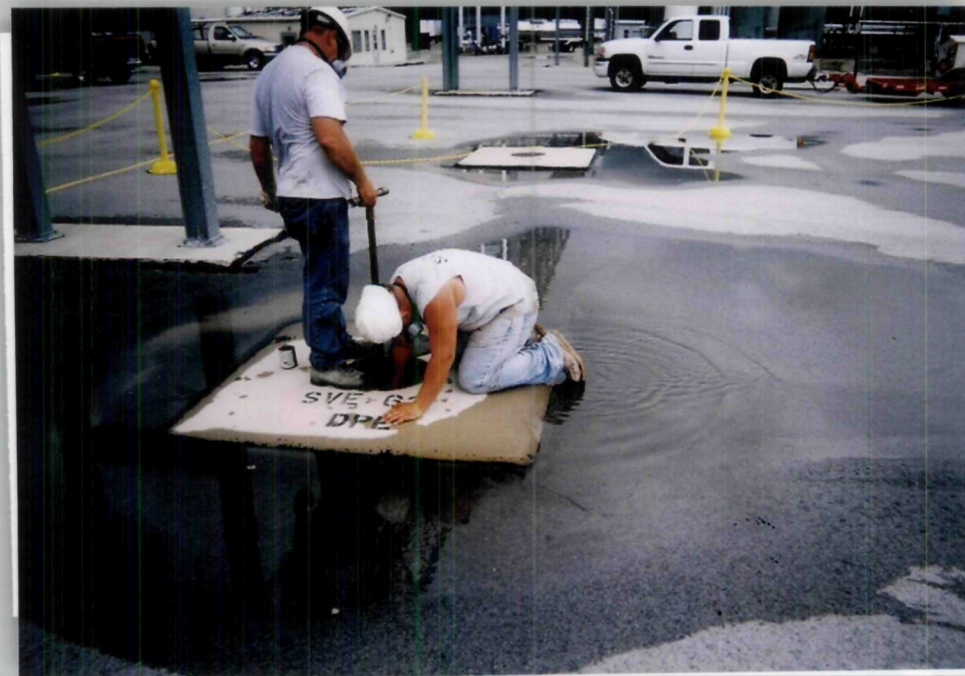
Site: American Chemical Service, Inc.
 Proj. #: 44728 AES [46526 RAC]
 Roll: 88 Photo #24
 Date: 8-03-06 Time: 1100
 Photographer: Larry Campbell
 Description: Photo facing north showing IES technician lowering DPE pump to final depth in well SVE63 and connecting air hose in well.

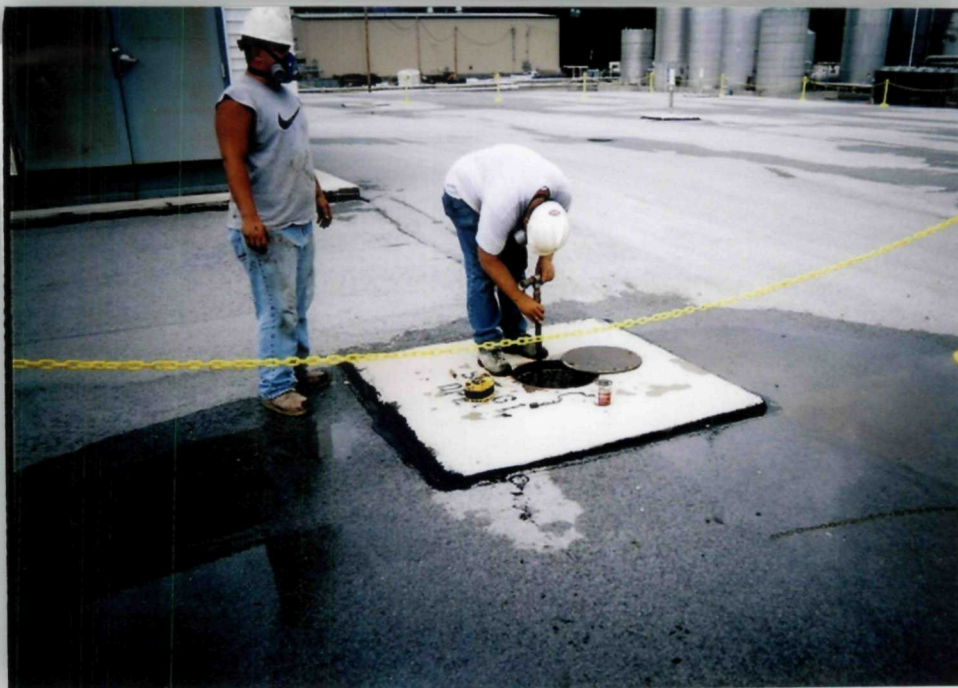
Site: American Chemical Service, Inc.
Proj. #: 44728 AES [46526 RAC]
Roll: 88 Photo #25
Date: 8-03-06 Time: 1104
Photographer: Larry Campbell
Description: Photo facing west showing IES technicians installing pitless adaptor into well SVE61.

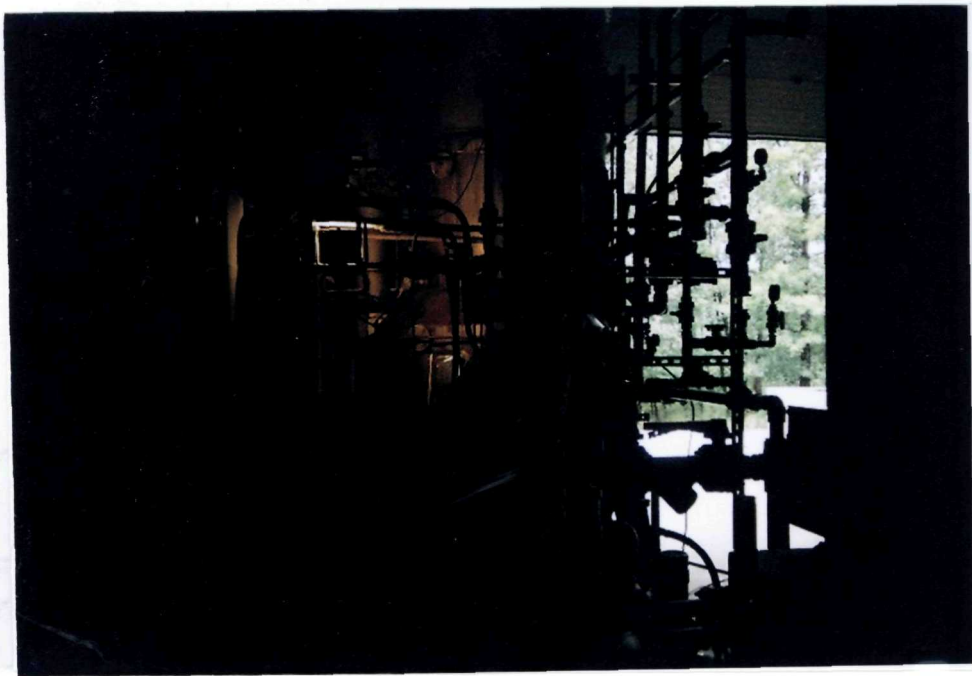
- MWH reported that it cleaned the nozzles and interior of thermox 1 scrubber and found a number of pin-holes through the side of the unit near the location of the gas vapor inlet port. BVSPC observed Vidimus weld a Hastalloy™ steel patch over the pinholes on August 3.

Site: American Chemical Service, Inc.
Proj. #: 44728 AES [46526 RAC]
Roll: 88 Photo #27
Date: 8-03-06 Time: 1116
Photographer: Larry Campbell
Description: Photo facing west in GWTP showing
Vidimus welder welding patch (lighted rectangle) over
pinholes in side of thermox 1 scrubber.

- MWIT cleaned nozzles & interior of thermox (& found pin hole leaks on side of unit near location of gas vapor inlet port. Vidimus welded patch today on side of thermox unit
- Thermox 2 down for safety while working on Thermox 1.
